Geological and geotechnical investigation of a shallow translational slide along a weathered rock/soil contact for the purpose of model development and hazard assessment

B. Valley & K. Thuro

ABSTRACT: A key requirement for the implementation of any effective landslide hazard mitigation plan is the in-depth knowledge of the causes driving the instability. Often these causes are multiple involving not only geological, geotechnical and hydrogeological processes, but also anthropogenic influences. Differentiating between these different factors to identify the principal cause and trigger of a landslide is difficult. This paper presents results from a detailed analysis of one such landslide – the 2002 Lutzenberg landslide in eastern Switzerland, which involved three fatalities. Results obtained through an intensive field investigation combined with numerical modelling revealed that the underlying cause of the slide could be traced to adverse geotechnical and hydrological conditions, triggered through an exceptional precipitation event and the rupture of a water pipeline. Results from the numerical analysis suggest that the pipe didn't only rupture during the landslide event but that i

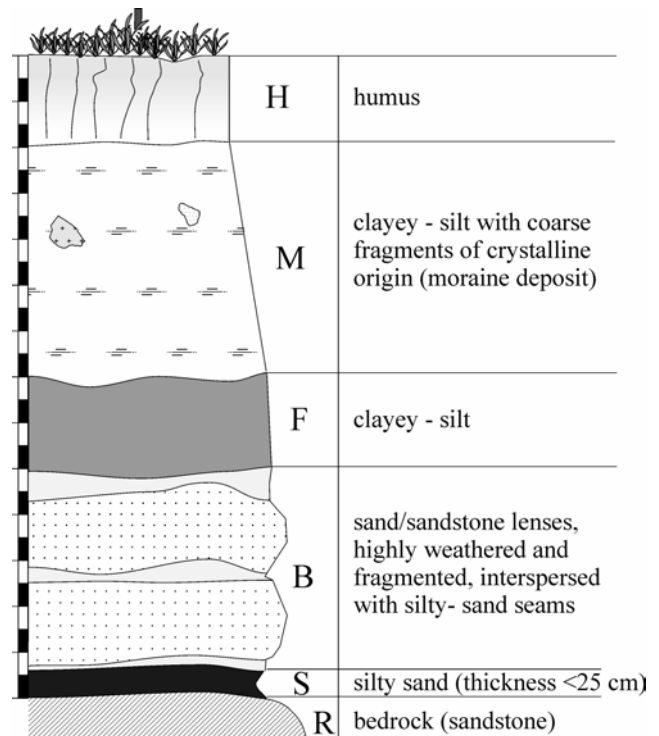
layer of clayey-silt containing coarse crystalline fragments (gravels, stones). This layer was interpreted as being a weathered moraine deposit varying in thickness between 2 and 3 m near the foot of the slope, and thinning out towards the top of the slope. Beneath this layer was found a similar clayey-silt but without the coarse fragments. Below this, forming the interface between the soil layers and the bedrock, was a thin layer (1-25 cm thick) of silty-sand derived from the direct weathering of the sandstone bedrock. This layer was held to be highly significant as it was observed that most of the shear surface had developed within this layer. In addition to the silty-sand layer, in some areas disturbed blocks of the underlying sandstone could be found disengaged and encapsulated within the overlying soil layers (Fig. 2).

Results from the investigation revealed that the depth of the soil cover varies from less than 1 m along upper sections of the slope to nearly 5 meters at the slope's foot. The underlying bedrock consists of alternating beds of marl and limey sandstones (from the freshwater Molasse - Aquitanian). The soil strata could be differentiated into five distinct layers (Fig. 2). At surface was a cover of humus, approximately 20 cm thick, which was underlain by a

Figure 2. Soil profile near the slide scarp.

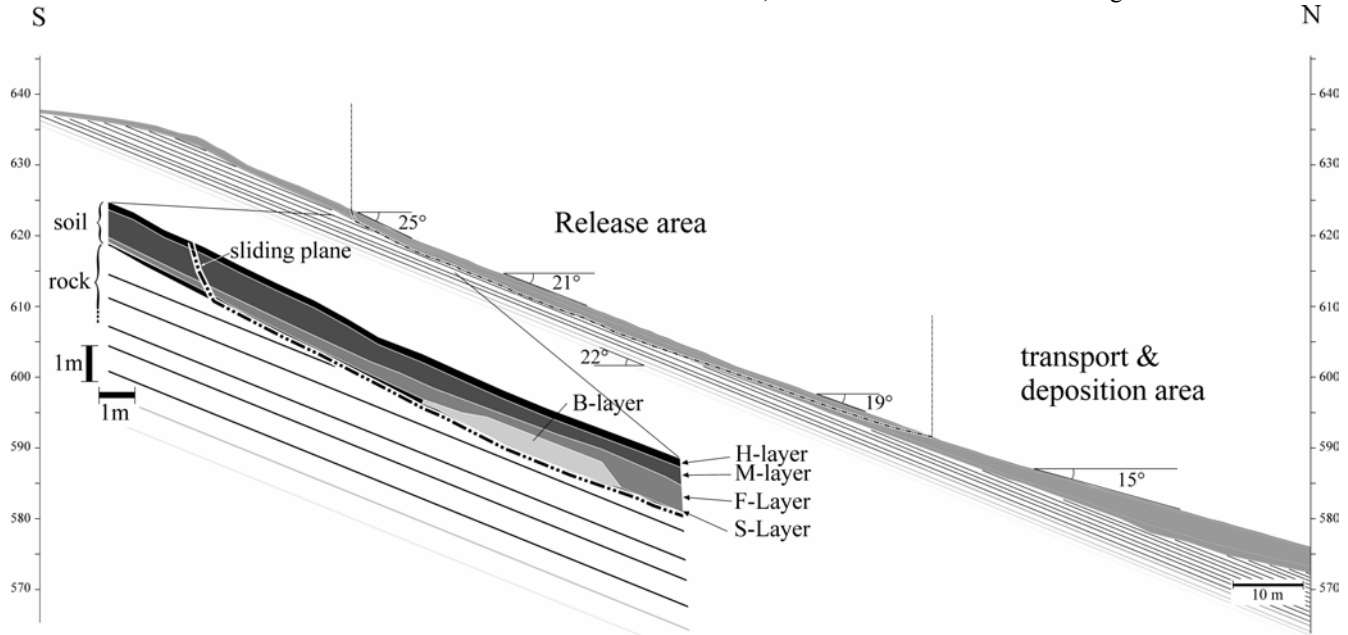
Figure 3. Geological cross-section of the 2002 Lutzenberg landslide taken through the centre of the slide mass.

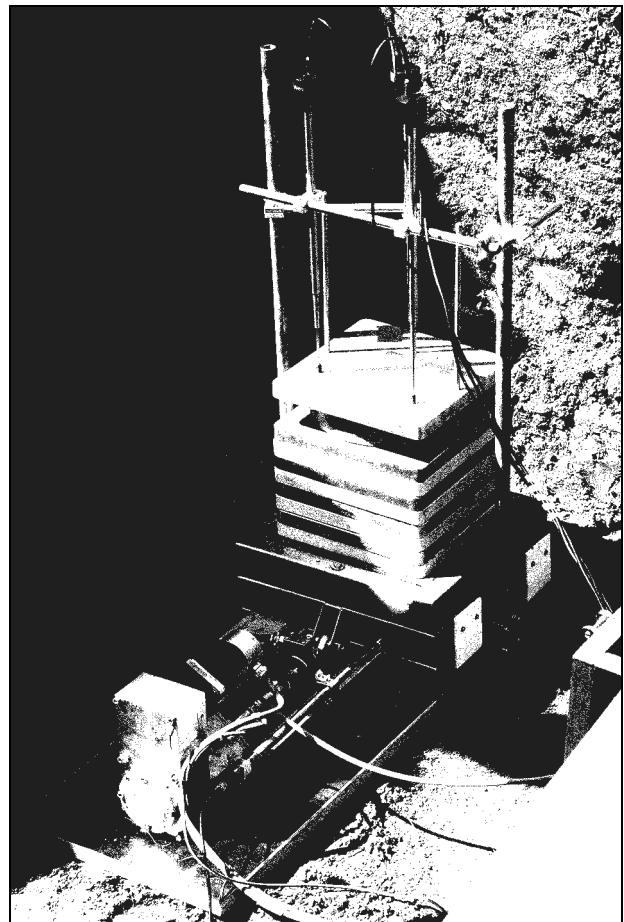
Tests performed *in situ* included two shearbox tests, and numerous penetrometer and shear-vain tests. The two *in-situ* shearbox tests were carried out in trial pits #7 and 8 (near the main scarp; see Fig. 1), using a 25x25x30 cm displacement-controlled shearbox (Fig. 4). Standard laboratory tests were carried out on 13 samples to ascertain grain size distribution and the Atterberg limits. An additional 4 samples were prepared for shearbox and permeability testing. The parameters obtained from these tests are given in Table 2.

Figure 4. *In-situ* shearbox test performed in test pit #7.

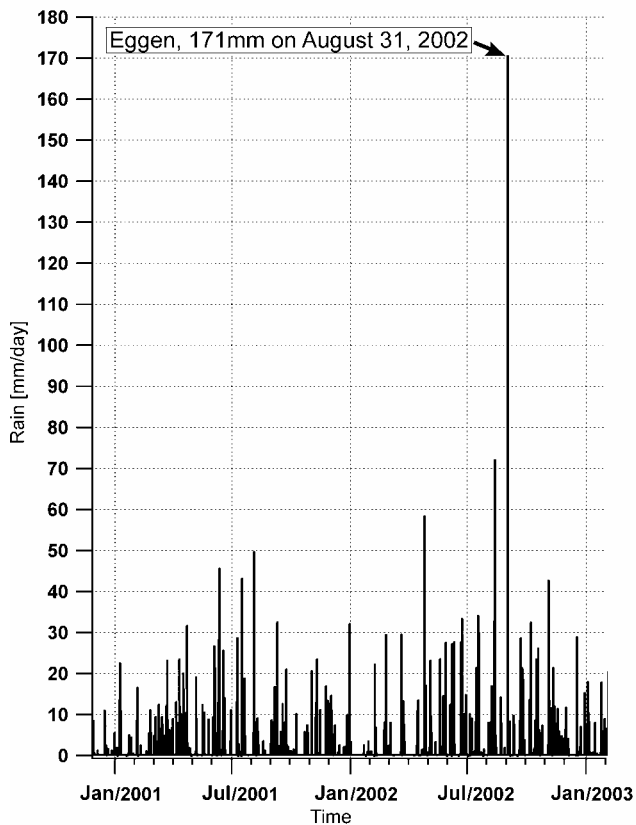
landslide. Prior to the landslide, a period of intense precipitation had occurred including 170 mm in one day as was recorded at a nearby weather station (Eggen; Fig. 5). This can be compared to the 1690 mm

Figure 5. Precipitation recorded at Eggen weather station near Lutzenberg

total precipitation recorded for all of 2002. This exceptional rain event was regarded *a priori* as the principal trigger of the landslide.

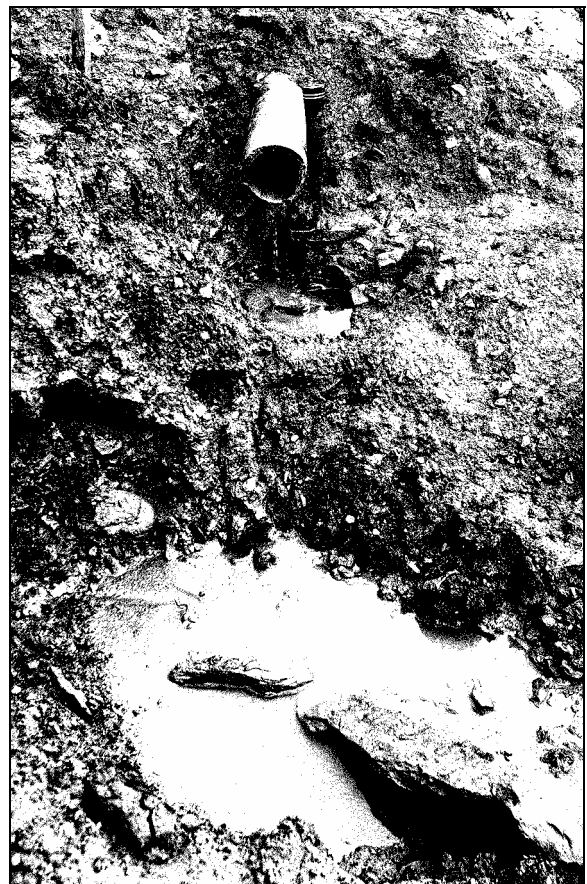
The water pipe was positioned along the soil-bedrock interface. In some places it was trenched into the weathered sandstone bedrock, and in other places it was located solely within the soil. At the point where one of the side scarps of the landslide developed, it was sheared on one side as the pipe exited a rock trench to continue within the soil (Fig. 6).

Figure 6. Photo of the broken water pipe where it intersected the western side scarp of the slide body.

Assuming the pipe was leaking prior to sliding, the elevation difference between the reservoir and the location of the broken water pipe would allow for a maximum pressure of 500 kPa. Due to pressure losses into the formation, a steady state pressure of 100 kPa was estimated as being more realistic.

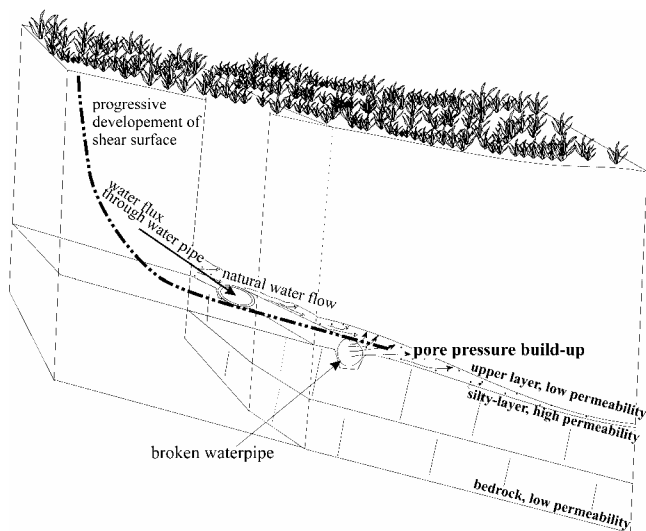
Based on the detailed site investigation, a working hypothesis was developed with respect to the landslide cause and trigger (Fig. 7). In it, the silty-sand layer acts as a confined aquifer along which elevated pore pressures (i.e. artesian conditions) may arise during periods of high precipitation. These increased pore pressures would result in a significant reduction in effective stresses along the soil-bedrock interface. Whether these pore pressures could reach destabilizing levels naturally, was investigated through a series of limit equilibrium and finite element models. Only the numerical modelling results are presented here, as the limit equilibrium analysis produced similar but less informative results.

Figure 7. Working hypothesis for the primary cause of failure.

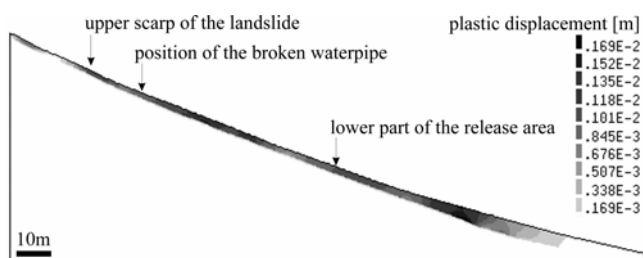
Figure 9 shows the modelled results assuming a dry slope, for which the silty-sand shear strength parameters required for failure were back calculated. As expected, these values were unrealistically low ($c=10$ kPa, $\phi = 5^\circ$). Moreover the dry slope model predicted a failure surface developing in the lower half of the slope, much further down than that of the actual failure.

Figure 9. Model results assuming a dry slope. Back-calculated shear strength values required for failure were unrealistically low ($c = 10$ kPa, $\phi= 5^\circ$).

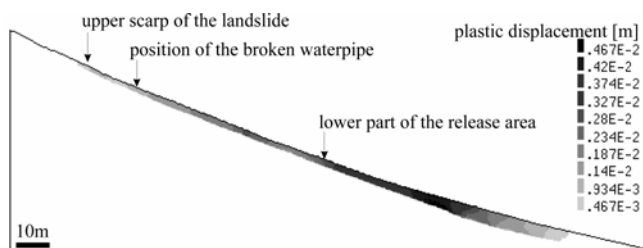
When the model assumed fully saturated slope conditions (Fig. 10), failure could be achieved using feasible strength properties but lower than those obtained during testing. Again, as in the previous case, the modelled failure initiates and develops along the lower half of the slope and not where the actual failure had occurred. Thus, a failure scenario involving a fully saturated slope, representative of the conditions that would be encountered during periods of heavy precipitation could not fully explain the Lutzenberg slope failure.

Figure 10. Model results assuming fully saturated slope conditions. Results in this case incorrectly predict the extent of the failure surface.

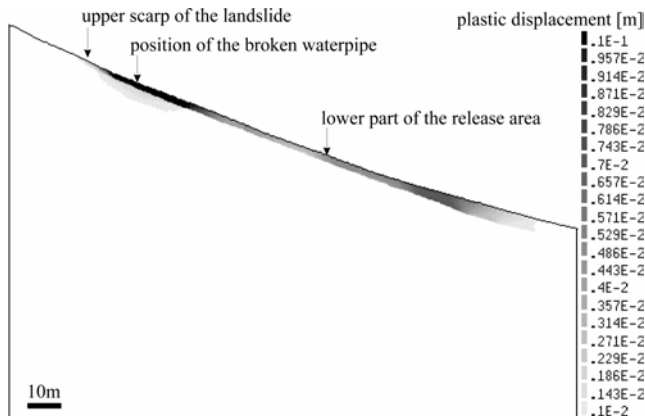
The final model scenario included a fully saturated slope, arising due to heavy rainfall, and a leaking water pipe. The leaking water pipe was incorporated into the model as a 100 kPa pore pressure source that was allowed to diffuse outward into the slope. Results from this scenario (Fig. 11) produced the best fit by far. As before, the shear strength values used coincided with the minimum values obtained through the in situ and laboratory tests. With respect to the location and dimensions of the failure surface, a near exact fit was obtained between the model and the actual slope failure.

Figure 11. Model results assuming a fully saturated slope with a leaking water pipe.
