A fortified site to defend the Kerma basin before the Egyptian conquest

Matthieu Honegger and Jérôme Dubosson

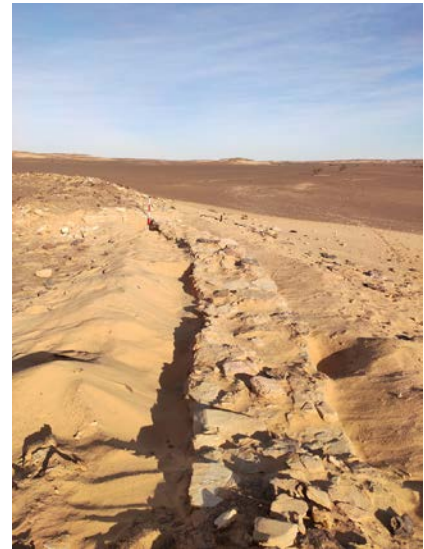
Figure 5. Portion of the wall of the enclosure after surface cleaning (Area 6).

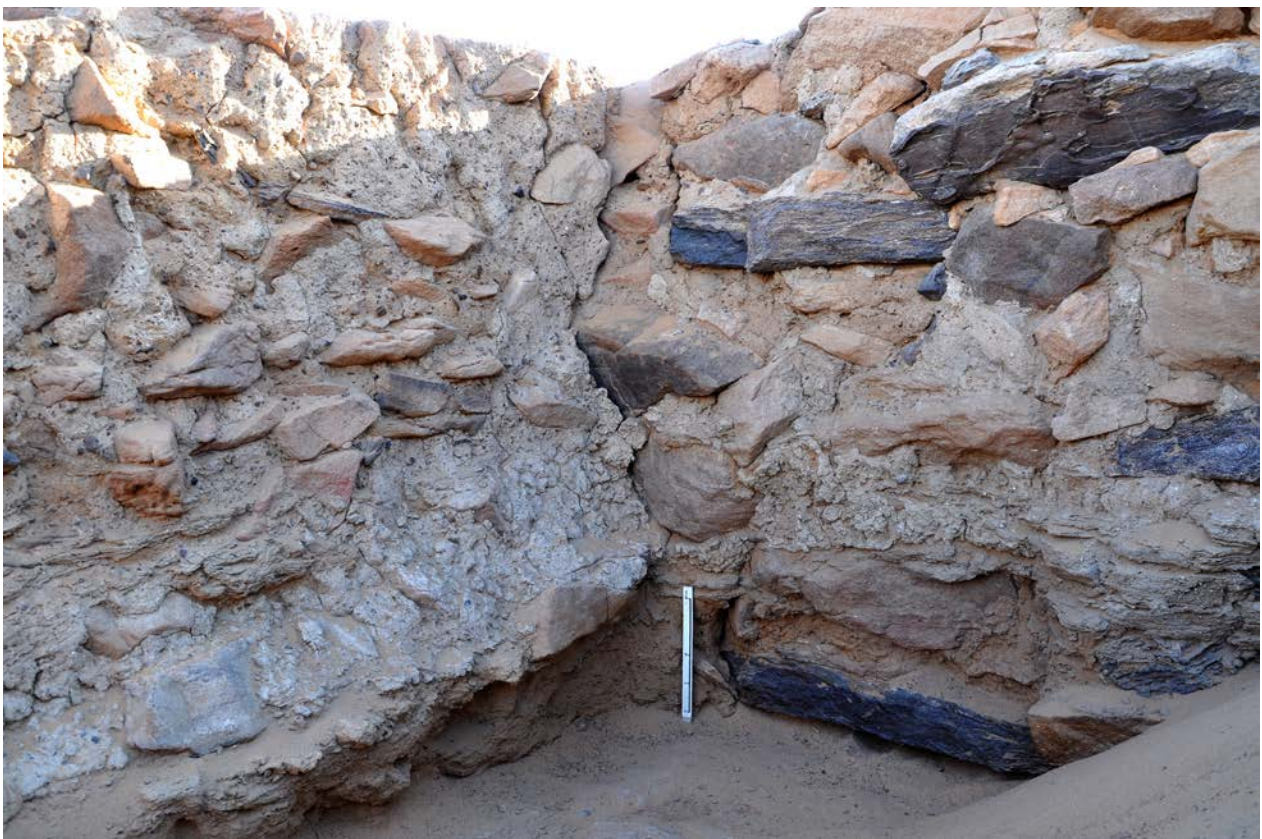
Figure 6. Elevation of the enclosure wall on the right and of an inner structure wall on the left (Area 3). The foundations of the enclosure wall appear to be only 0.2m deep.

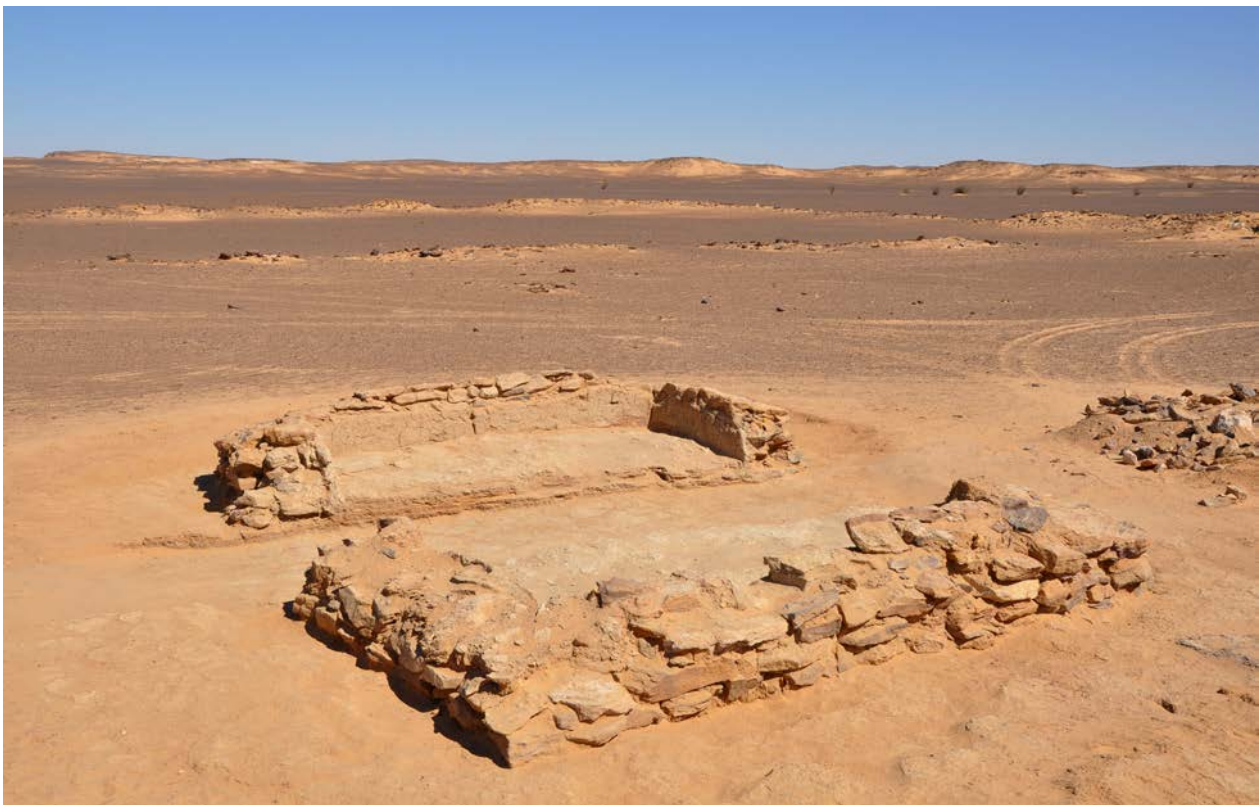
Figure 7. View of Building 1 taken from the south-west. The trench made by the looters cut the building in two parts and. In the norther part, a grinding stone still in place is visible in the north-western angle.

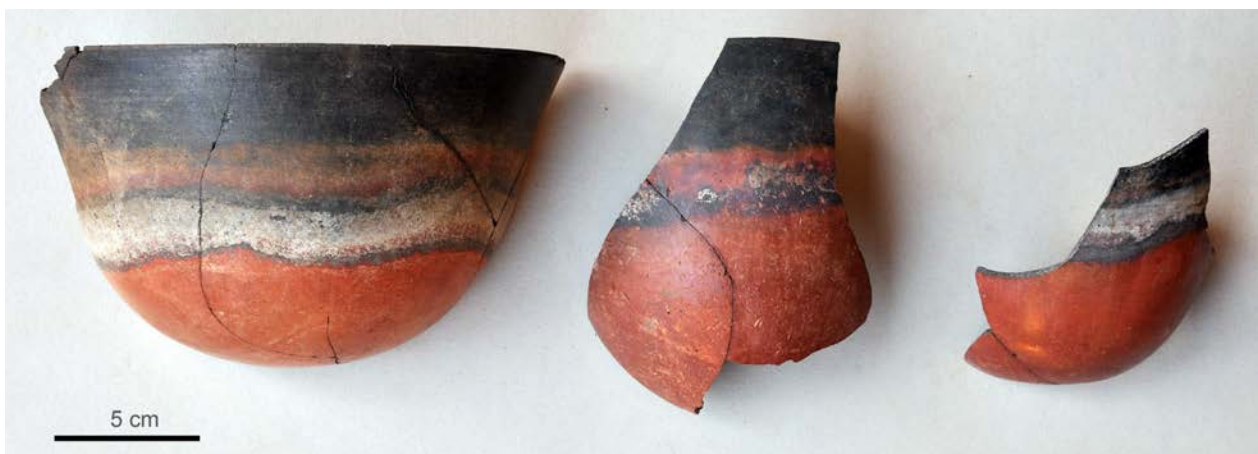
Figure 13. Beakers found close to the eastern entrance.

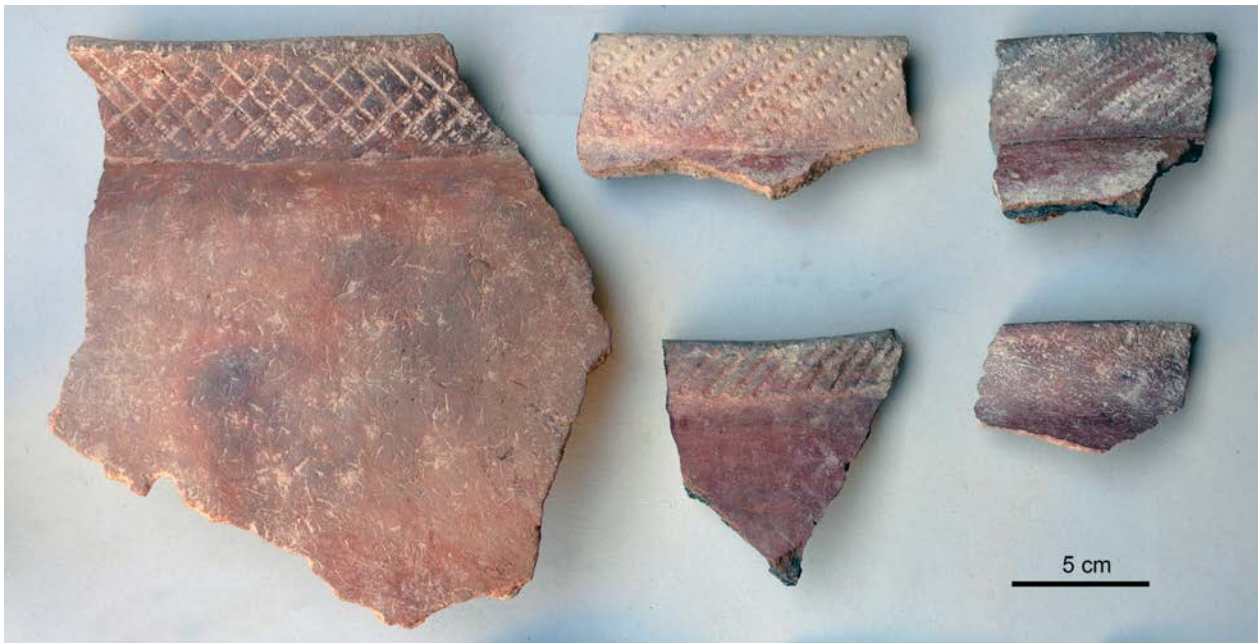
Figure 14. Fragments of jars found in Building 1.
