Geological and geotechnical investigation of a shallow translational slide along a weathered rock/soil contact for the purpose of model development and hazard assessment

B. Valley & K. Thuro

ABSTRACT: A key requirement for the implementation of any effective landslide hazard mitigation plan is the in-depth knowledge of the causes driving the instability. Often these causes are multiple involving not only geological, geotechnical and hydrogeological processes, but also anthropogenic influences. Differentiating between these different factors to identify the principal cause and trigger of a landslide is difficult. This paper presents results from a detailed analysis of one such landslide – the 2002 Lutzenberg landslide in eastern Switzerland, which involved three fatalities. Results obtained through an intensive field investigation combined with numerical modelling revealed that the underlying cause of the slide could be traced to adverse geotechnical and hydrological conditions, triggered through an exceptional precipitation event and the rupture of a water pipeline. Results from the numerical analysis suggest that the pipe didn't only rupture during the landslide event but that i

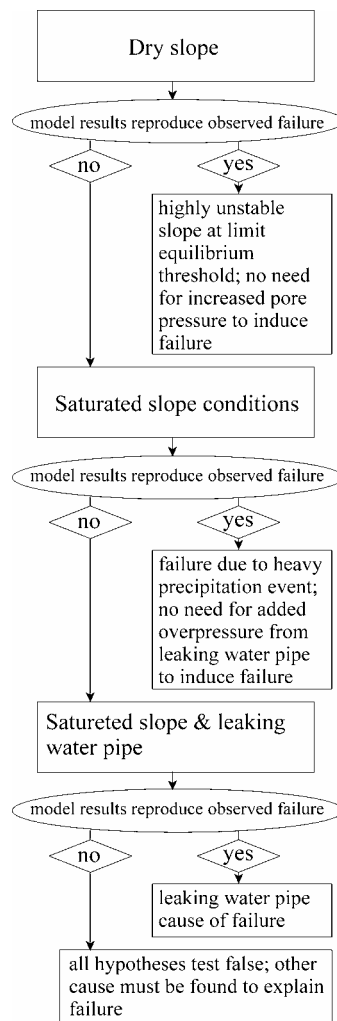
To ascertain the cause of failure, models were run testing different scenarios with increasing degrees of complexity. Initial models were evaluated assuming dry slope conditions, with later scenarios assuming fully saturated conditions (i.e. coincident with a period of heavy precipitation). The final scenario tested included the added influence of a leaking water pipe. For each scenario, the average and minimum values for the silty-sand (Table 2) were used and the respective results compared to field observations. Depending on the fit, or the assumptions required to achieve a fit, the model scenario was then validated or rejected (Fig. 8).

Figure 8. Modelling procedure and scenarios tested to determine cause of slide.
